Aptos Creek Watershed

Assessment & Enhancement Plan

Hydrologic & Water Quality Analysis

by: Swanson Hydrology & Geomorphology
Nicole G. Beck, PhD and Maggie Mathias

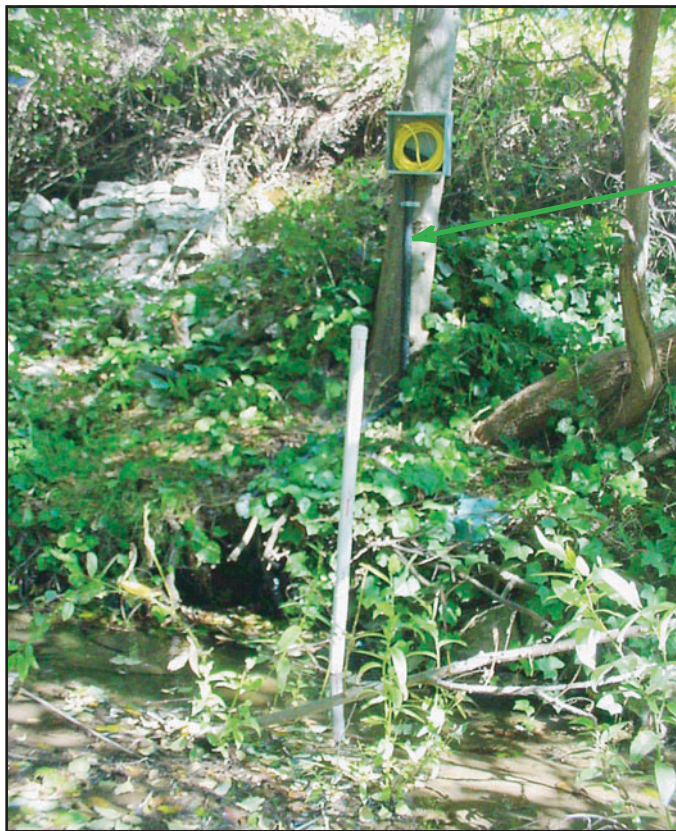
Figure 8A: Global Water WL-14 depth gage and housing located on mainstem Aptos Creek upstream of Spreckles Drive. Data logger is housed in an electrical box affixed to tree, yellow cable runs down tree to the water through black PVC. Sensor is located at bottom of water column, secured to PVC by cable ties. The white PVC in the foreground is the staff plate, used to record depth concurrent with data downloads.

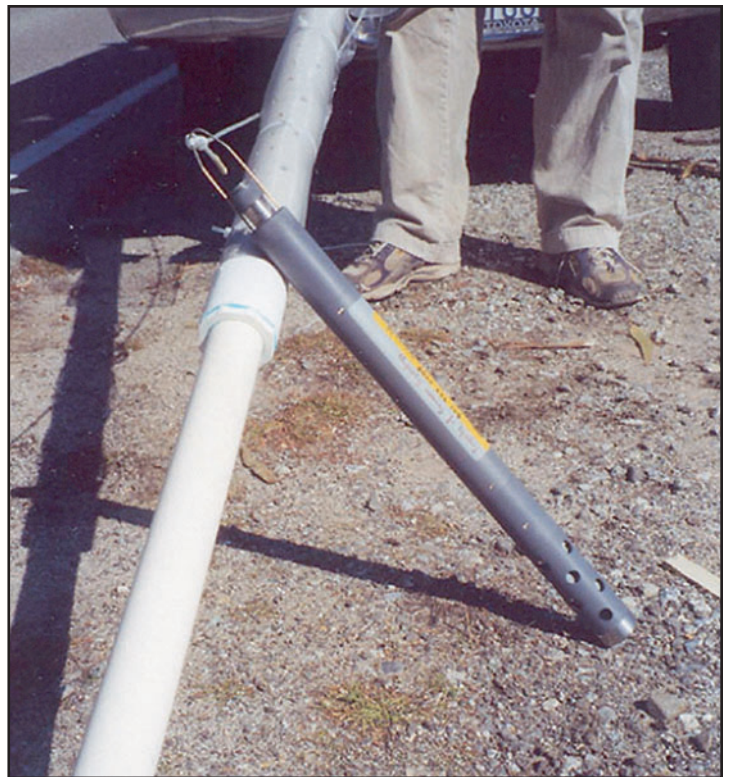
Figure 8B: YSI 600XLM water quality instrument used to collect salinity, water temperature, water depth, dissolved oxygen, conductivity, and pH on 30-minute time intervals. This instrument was installed in the Aptos Lagoon from August 20 to October 21, 2001.
